FIELD REVIEW REPORT

Date 06/14/05 Feature Crossed State Route 1 Load Rating Unkn MP 12.83
 Year Built 1948 (1996) Width 23' Length 137' No. of Spans 2 Cols/Bent 2
 CT Br. No. 36-0012 Dist. 04 Co. SCr Route 1 Suff. Rate Unkn

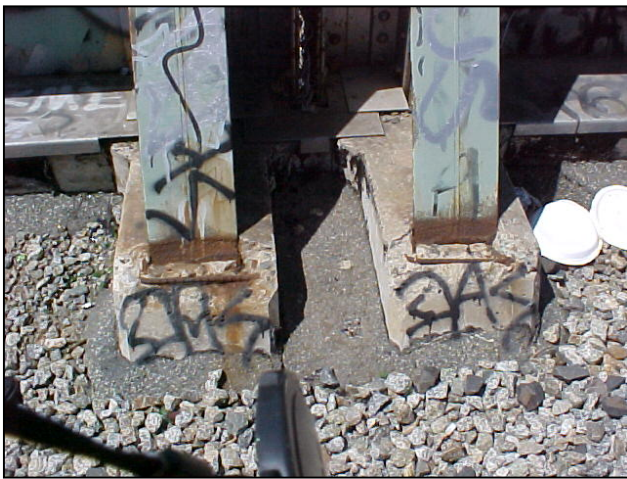
Spalling of Concrete Base at Guardrail Stiffener Support

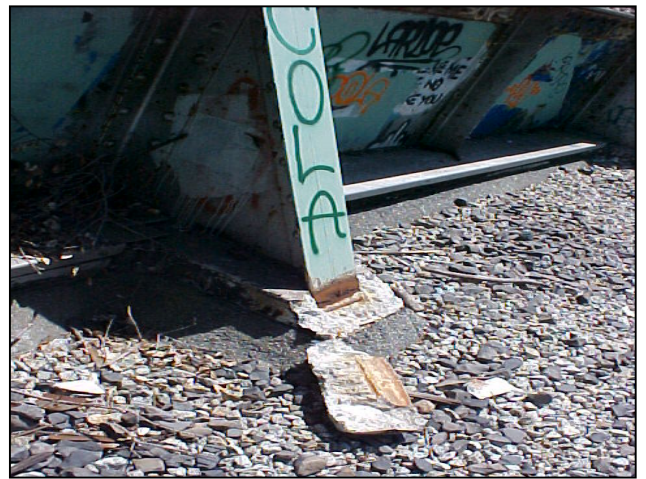
Spalling at Base of Guardrail
