Santa Cruz Industrial Lead Supplemental Structural Assessment Report

Santa Cruz County Regional Transportation Commission

HNTB

June 23, 2006

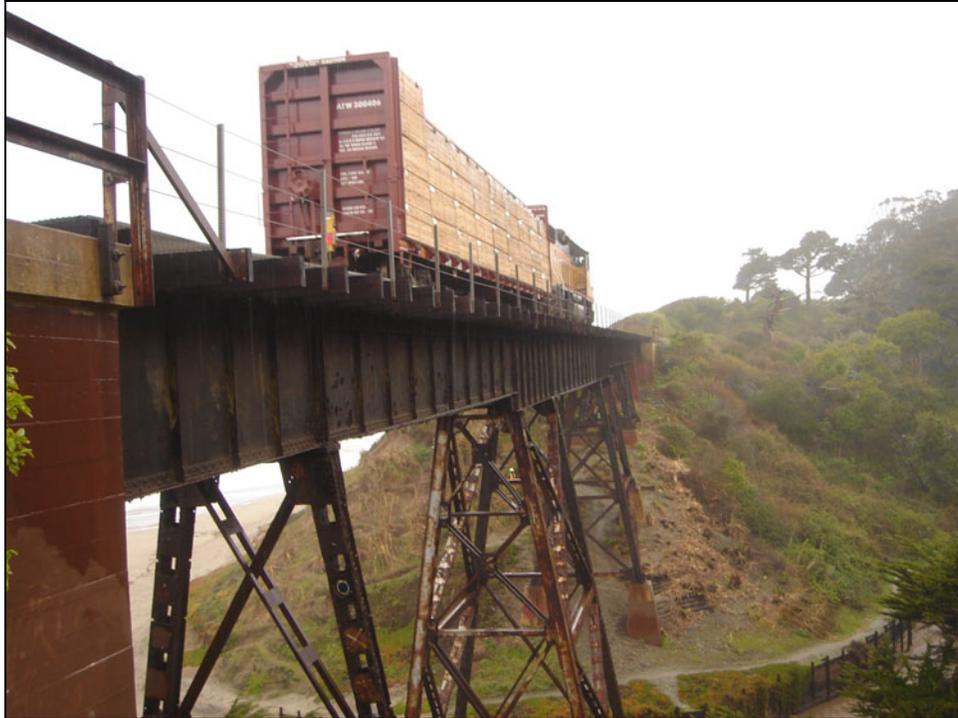
Figure 2 - MP 9.09 Leonard Gulch (La Selva Beach Trestle)

The load rating for the MP 9.09 Leonard Gulch (La Selva Beach Trestle) is dependent upon the condition of the column longitudinal and transverse bracing and the bracing connections. Some of these items were observed to be in poor condition, with significant corrosion and section loss. Failure of the bracing or connections may lead to a reduced load rating and the possibility of column failure. As noted in Section 9 of this report, the bracing and connections should be replaced in the near future in order to avoid possible column failure.

MP 9.09 Leonard Gulch (La Selva Beach Trestle – Steel Deck Plate Girder)
<i>General</i>
<ul style="list-style-type: none"> • UPRR recently (8/22/05-2/09/06) made repairs to the steel bents for this structure
<i>Recommended Repair Work</i>
<ul style="list-style-type: none"> • General repairs to columns to fix areas of significant section loss • Repairs to Bent 4 columns • Repairs to Bent 2 columns • Replace severely corroded longitudinal bracing for selected members at Bents 3-4, Bents 5-6, and Bents 7-8 • Replace severely corroded transverse bracing members at selected Bents • Replace severely corroded lacing bars in selected columns • Replace selected girder bottom laterals and connection plates • Replace selected girder top laterals and connection plates • Replace selected girder cross frames • Repair girder bottom flanges and webs where corrosion occurs at cross frames and bearings • Replace corroded rivets, bolts, etc.

<i>Optional Work</i>
<ul style="list-style-type: none"> • Clean and paint substructure steel • Seismic retrofit • Replace missing catwalk timbers
<i>Maintenance Program</i>
<ul style="list-style-type: none"> • Bi-annual inspection of bridge • Replacement program for girder top and bottom laterals • Annual cleaning and inspection of girder bearings • Annual inspection of retaining walls along channel under structure • Replacement program for retaining wall timbers and soldier piles along channel

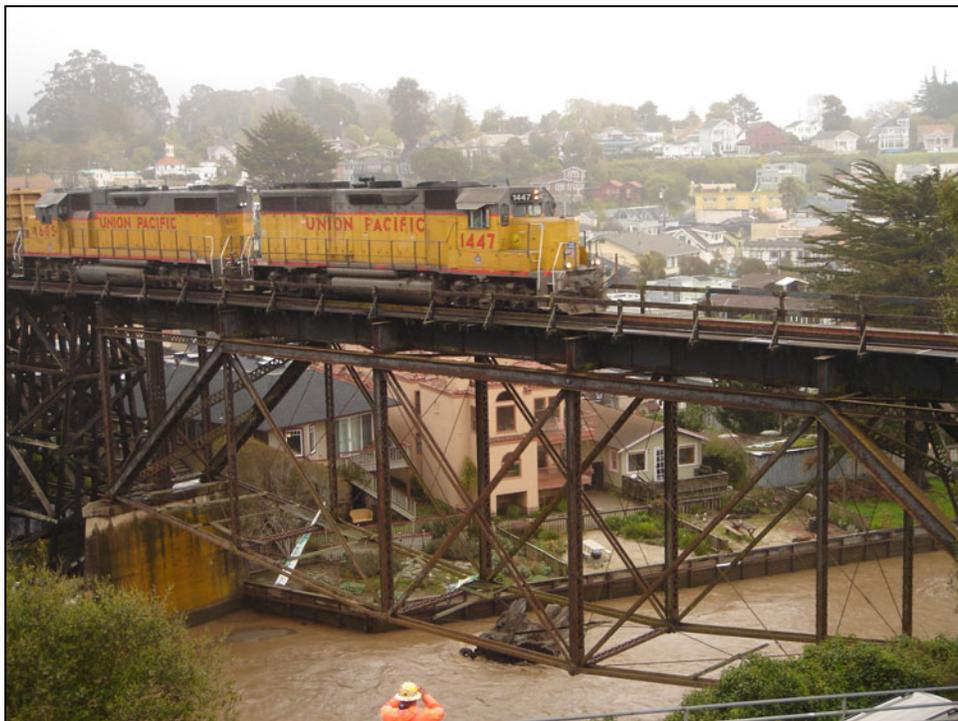
Figure 3 - MP 15.89c Capitola Crossing

It should be noted that for the structure at MP 15.89c the equivalent rating for the 286,000 lb cars (E-60.4) exceeds the Normal (E-37.7) and Maximum (E-57.7) Load ratings for the stringers, based on a 25 mph operating speed. For a 10 mph operating

speed, the Maximum Load rating increases to E-65.1. In order to keep the bridge stresses to within the Maximum Load rating, it is recommended that operating speeds not exceed 10 mph. More frequent inspection intervals are also recommended for this bridge due to the possibility that this bridge may be consistently loaded above the Normal and Maximum Load rating.

MP 15.89c Capitola Crossing (Steel Deck Truss, Pinned)
<i>Recommended Repair Work</i>
<ul style="list-style-type: none"> • Clean and repair bearings, rollers, anchor bolts (4 each) • Replace missing or broken fasteners in girder cross frames and laterals • Repair corrosion in selected top chord members
<i>Optional Work</i>
<ul style="list-style-type: none"> • Seismic retrofit • Clean and paint for extended bridge life
<i>Maintenance Program</i>
<ul style="list-style-type: none"> • Quarterly bridge inspection • Monitor floor system bracing for program repairs • Monitor pin connections for program repairs

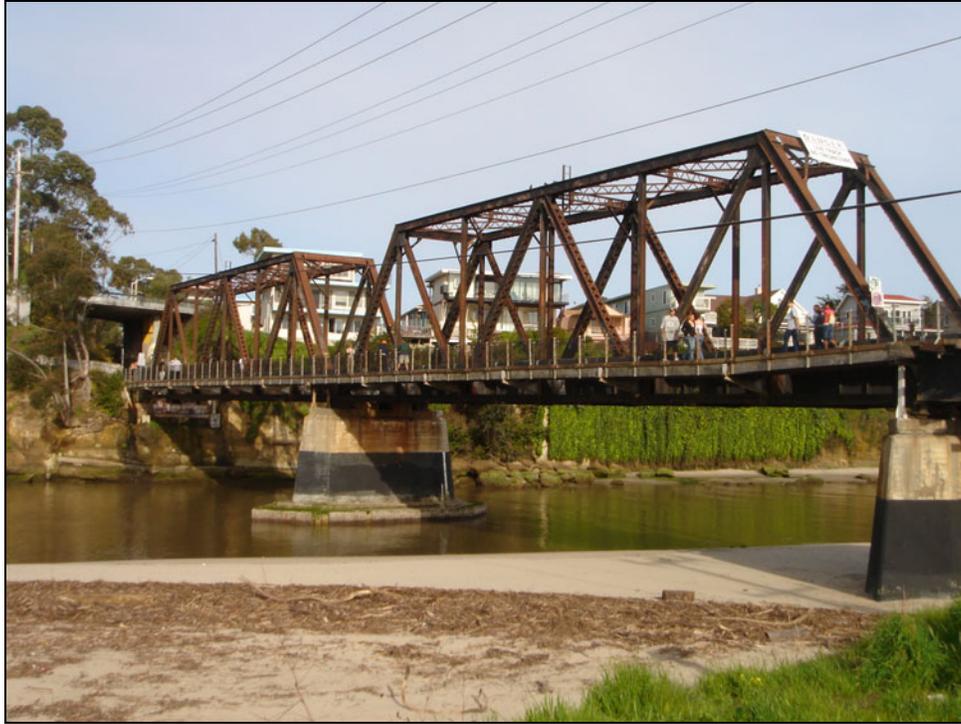
Figure 4 - MP 19.43a San Lorenzo River Crossing

The April 1-2, 2006 inspection revealed that the bridge was generally in fair to marginal structural condition, with up to 15% section loss in the main truss members, some section loss in floor beams and stringers, and up to 100% section loss at many lateral braces.

The bearing assemblies and anchor bolts are severely corroded and damaged. The bearings may be sheared off under the design earthquake. As a retrofit measure, a bearing replacement is required. In order to minimize the seismic forces that will be transferred to the minimally reinforced piers, earthquake isolation bearings are recommended. The isolation bearings will serve to minimize the forces to the pier and foundation system so that a substructure retrofit can be avoided.

It is unlikely that the current bracing system will resist the seismic design forces. In addition, most members of the lateral bracing system have shown a significant section loss due to corrosion and other effects. The entire lateral bracing system – top and bottom laterals, top strut and sway (knee) bracing and bottom bracings and portal bracing – will likely need to be repaired or heavily retrofitted.

Retrofit of old truss members is a labor intensive and expensive operation which includes removing old rivets and repairing lacing members. The construction cost shown in the table below is an estimate for the cost that is needed to bring the truss spans to the current seismic design standards. The cost was divided into two portions – cost for service load repair and cost for seismic retrofit. The service load repairs must be completed either before or at the same time that the seismic retrofit repairs are completed.

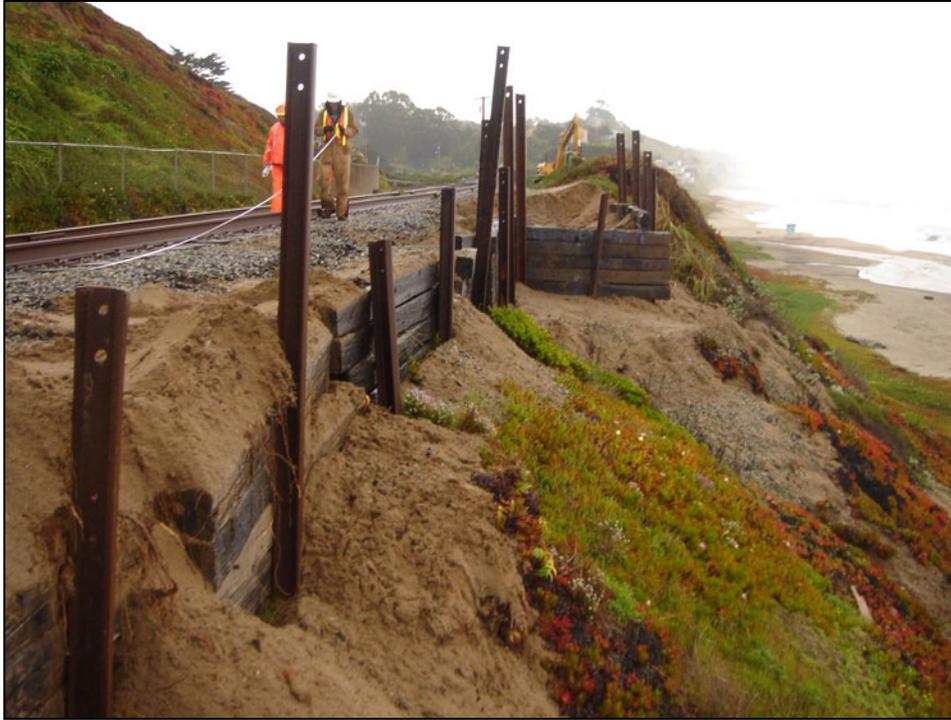
Figure 13 – Wall Between MP 8.64 and MP 9.09

The condition of the retaining wall at MP 8.64 was in a poor condition at the time of the inspection. This retaining wall supports the embankment for the track roadbed and its close proximity to the track poses a potential risk to rail operations although at the time of the inspection there was no deviation in line or surface of the track and the track appeared stable. Also, the UPRR had a contractor in the area making repairs to the drainage and the retaining wall at this location. It is recommended that a follow up inspection be made to verify the extent of repairs made and if further repairs need to be made. Recommended repair work includes repairs noted at the time of the inspection. The

recommended repairs include 260 feet of reconstructed retaining wall and the restoration of the drainage ditch along the track roadbed.
