Santa Cruz County Regional Transportation Commission

Track Maintenance Planning / Cost Evaluation for the Santa Cruz Branch

Watsonville Junction, CA to Davenport, CA

Prepared for Egan Consulting Group
December 2009

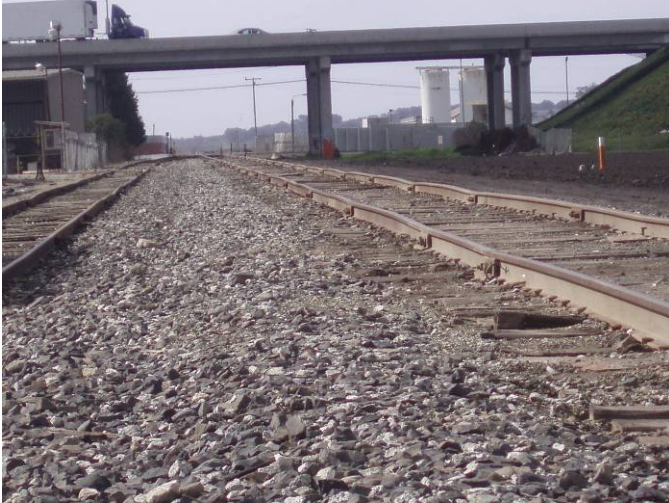
Surface bent rails near MP 2.5, between Ohlone Dr and the State Highway 1 overpass in Watsonville. This section is one of the worst for surface bent rails.

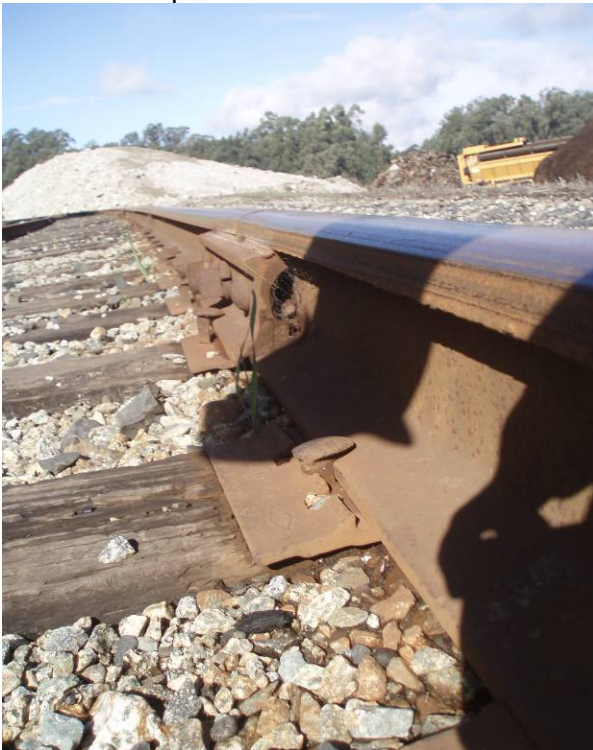
This joint bar shows evidence of wheel flanges striking the top of the bar. While wheel flanges are normally maintained at a relatively constant geometry, if the top of the rail is worn-down sufficiently, the flanges can contact the joint bars. This condition places unusual stresses on the joint bars and bolts, and the pounding makes it difficult to keep the bolts tight.

The tie plate in the foreground is of a style suitable for larger rail, but has been modified with an extra spike hole, closer to the rail, to fit this size rail. This is considered poor practice, as it reduces the number of spike holes available. Since the plate is too large to fit the rail, the shoulder on the inside of the plate is not serving any function.

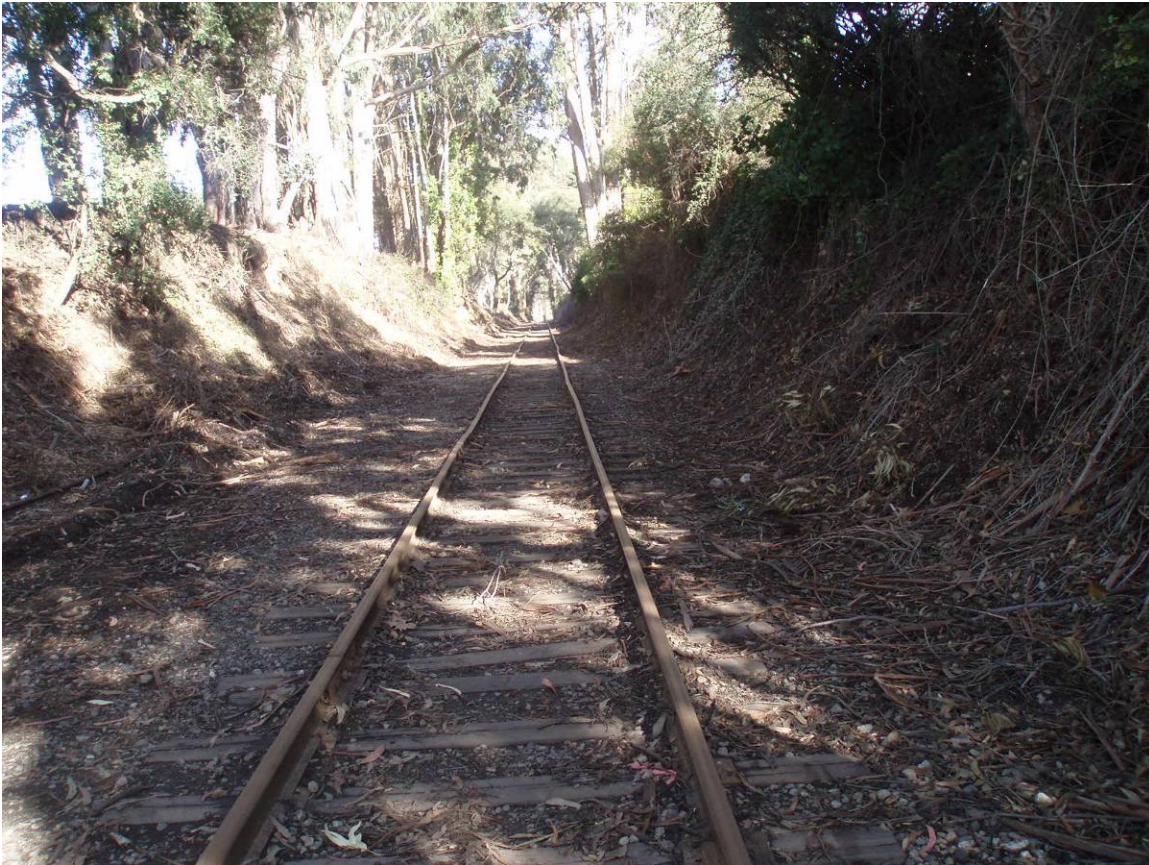
In areas of “poor” ballast conditions, contaminants are not confined to the surface of the track, but rather extend downward into the ballast section and into the subgrade. These are much more difficult to mitigate, since the contaminants cannot simply be pushed away. And, in general, the root cause of the fouled ballast may be more difficult to address. Often, these conditions are found in areas where there are cuts on one or both sides of the tracks, but the cuts are of inadequate width to allow for a proper drainage ditch. The site geometry that encouraged construction of a cut of substandard width also tends to be associated with over-steepened walls of the cut. As a result, material erodes or sloughs off the walls of the cut and, with no drainage ditch to intercept debris, the material accumulates on the track, perhaps flowing for long distances between the rails. A prime example of this situation can be found near Capitola, between MP 15.3 and MP 15.7, in the cut between Monterey Avenue and the Grove Road private crossing.

The cut between Monterey Ave and the Grove Road private crossing has over-steepened walls. Material is sloughing off the cut walls and has completely filled the drainage ditches. Contaminants are washing off the adjacent roadways, at the top of the cut, onto the track. Debris from trees has accumulated to the point where it has contaminated the ballast. Ties conditions in this area are worse than average, since the ties are continuously wet. Track surface, alignment, and rail joint conditions have also suffered as a result of the fouled ballast and tie conditions. There are other segments similar to this along the line, chiefly between Buena Vista Road and Santa Cruz.

The simplest way to address the ballast conditions in such situations is to raise the track and add more ballast, with the idea that the track can be raised high enough to get it above the material that is fouling the ballast and, by lifting the track higher, create a *de facto* drainage ditch. In some situations, this will be effective, but in other situations,

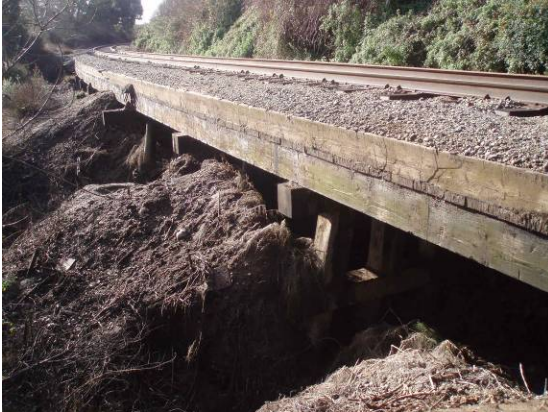
Trestle near MP 4.85 completely filled with sand from hillside above.

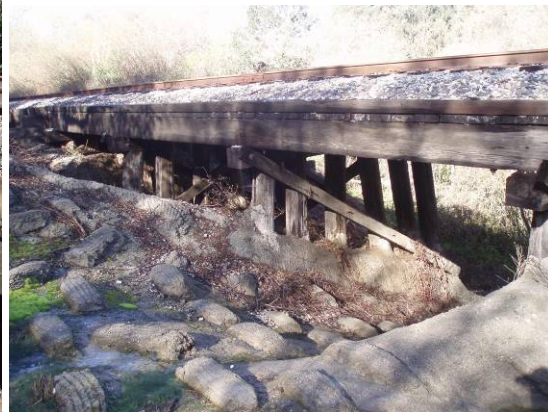
performed the concrete work. Just as being surrounded with sand promotes rot of the timber, the concrete has a similar, and perhaps worse, effect. This situation should be addressed immediately by addressing the fundamental drainage issues. In addition, the conditions of the structures should be reviewed by an engineer with a background in railroad structural evaluation.

Trestle near MP 6.01 with concrete energy dissipaters and channelization. Bents cast in concrete.

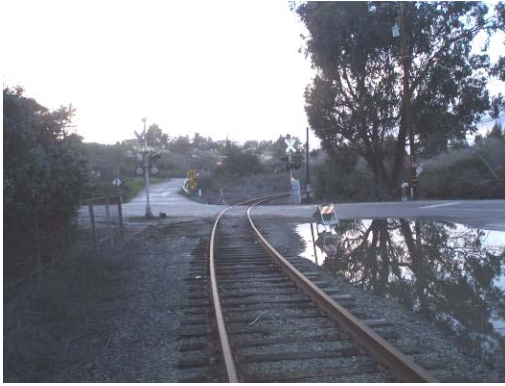
Buena Vista Road crossing. There is evidence that the water floods the tracks. The County Road department has been attempting to address drainage here. Sharp curve places a premium on tie condition.

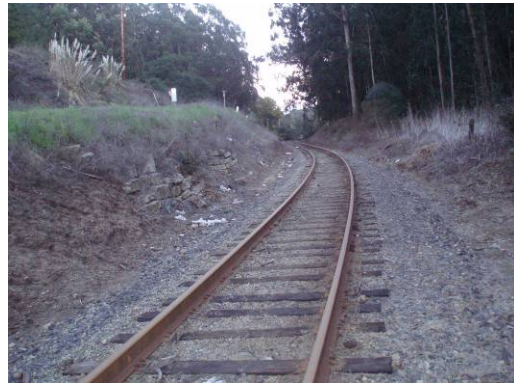
Retaining wall south of Buena Vista Road. Appears to be slow movement of this wall. Road above drains onto track.

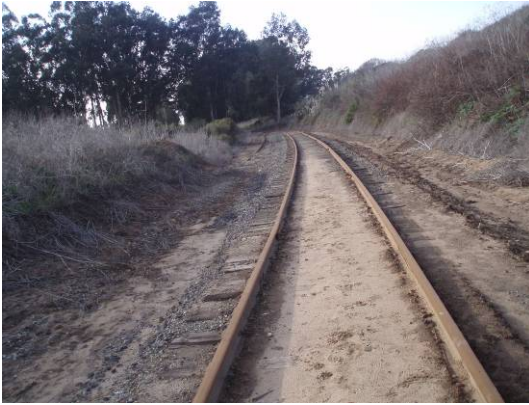
At approximately MP 8.3 to MP 8.4, there is a turnout and maintenance of way spur. This turnout is located in a curve, which places a premium on the condition of the rail and ties, though the current condition is adequate for Class 1 speeds. There is a significant amount of sand between the rails in this vicinity, and the drainage ditches are full of sand. If the ditches are cleared and the source of the sand is addressed, the tie life should be preserved relatively well. The source of sand appears to be a small trestle just uphill of this location. The drainage under the trestle has become filled-in with sand, filling-up to the level that water (carrying sand) flows along the track drainage ditches rather than under the trestle.

Looking north at sand on track near turnout at MP 8.4. Sand appears to be originating at short trestle which has filled-in. Rather than flowing under the trestle, sand flows along the track.

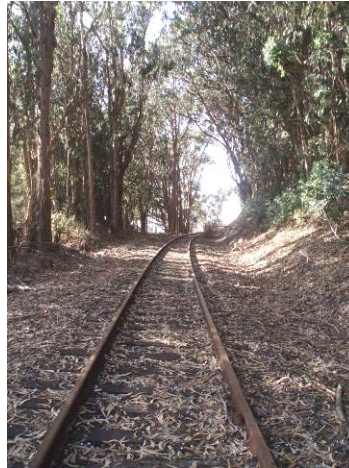
Looking north at ballast and drainage ditches fouled by leaves near MP 8.5. A similar condition exists near MP 9.3

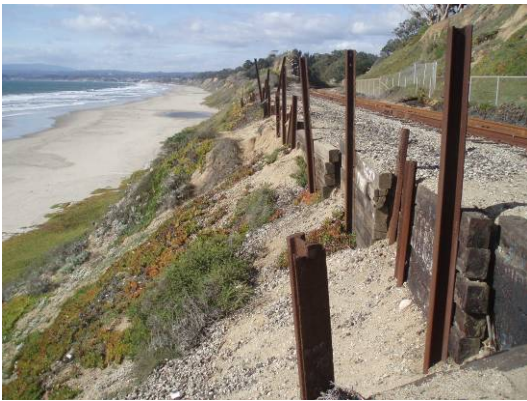
Retaining wall near MP 8.8. This wall is constructed of rails pounded into the embankment and railroad ties used for lagging. As the ties decay, the track will lose support. Nearby, there is a small hole developing in the ballast near a culvert location. This indicates that the culvert under the tracks is failing.

Between approximately MP 8.6 and MP 8.9, the track is supported by several short retaining walls. The walls do not appear to be of an engineered design, possibly with inadequate passive resistance in the soil to secure the rail which is serving as soldier piles. In addition, as the ties that form the lagging decay, the track will lose support. This situation was addressed in the Supplemental Structures Report. There is a culvert in this section that appears to be failing, with a small hole opening up in the ballast between the ties near MP 8.8. The track in this area has relatively few defective ties, but the rail has heavy curve wear. Pedestrian traffic in this area has eroded the subgrade near the La Selva Beach trestle approaches.

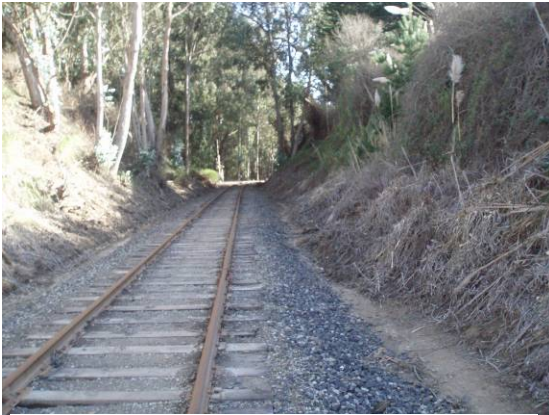
Between MP 9.4, and MP 9.7, the private crossing to the Celesians' camp at the end of Sumner Ave, the ballast is completely fouled with mud and/or leaves from adjacent fields, erosion of over-steepened walls of cuts, and overhanging trees. We recommend that this be one of the first areas to be addressed in the state of good repair program. Although new ties were reportedly installed in the track with the most recent tie program, the track is nearly completely covered in mud; these new ties will not last long. The walls of the cut at Trestle Beach Road appear to have been over-steepened, and are sloughing into the cut. There is evidence that the walls of the cut are moving. However, Union Pacific has established drainage ditches in both these areas in an effort to keep the problem from getting even worse.

Looking south from private crossing at MP 9.4 towards Trestle Beach Road, showing sloughing walls of cut and fouled ballast.

Recommendations for the base case preservation program are similar to those for the track between MP 2 and MP 2.8 in Watsonville. The track should be skeletonized (i.e., the fouled ballast should be excavated from the ends of the ties and disposed of off site) and subsequently, new ballast added. Ideally, the tie cribs should either be cleaned with a vacuum truck, and/or the track lifted several inches on fresh ballast to promote long tie life. The drainage patterns that create the mud – the fields above and to either side of the track – should be addressed in conjunction with the adjacent landowners.

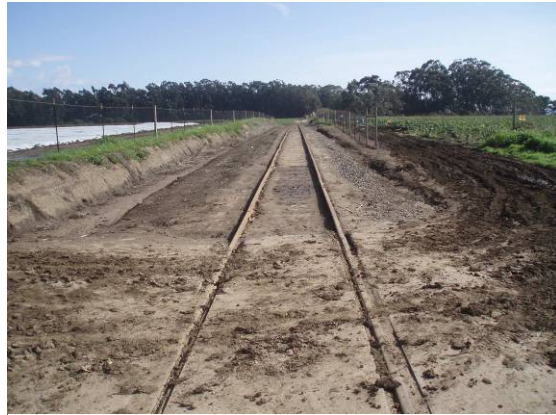
Looking south from private crossing at MP 9.7 towards area of fouled ballast. This view looks toward Trestle Beach Road, which is not quite visible in the background, beyond the vertical curve.

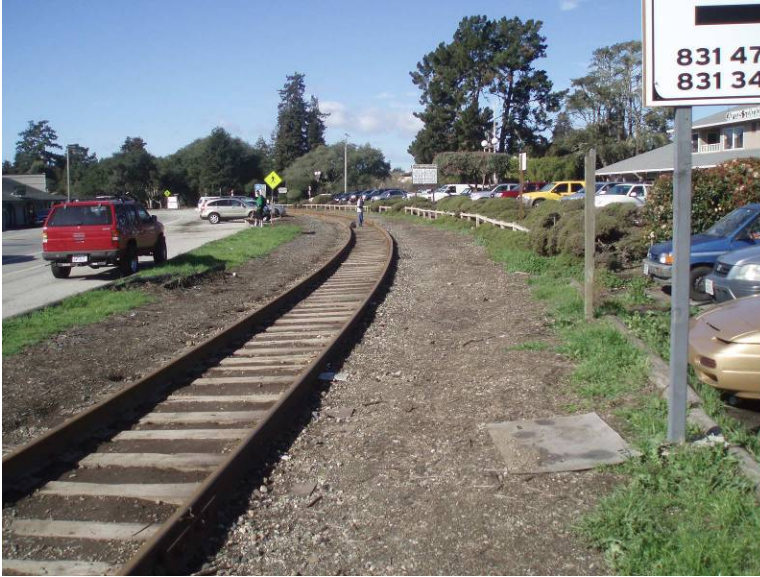
Between MP 12.5 and MP 12.6, at Aptos, the ballast is badly fouled with mud, to the point where the ties are covered in mud. This will greatly reduce the lifespan of the ties. The adjacent parking areas appear to encroach on the right-of-way, and the debris from the parking lots and pedestrian activity is one of the root causes of this ballast fouling. The heavy rail in this area helps mitigate the poor ballast conditions, though this rail is badly curve worn.

Private crossings at Aptos. Drainage ditches are obstructed, ballast is completely fouled with mud. Appear to be encroachments from adjacent parking areas.

As this is a higher cost item, addressing the fouled ballast by skeletonizing the track (and likely relaying the rail with a larger section) in this area has been included as a capital expense in the modernization estimate. However, to prevent this problem from recurring, the encroaching properties, landscaping, and pedestrian activity should be addressed.

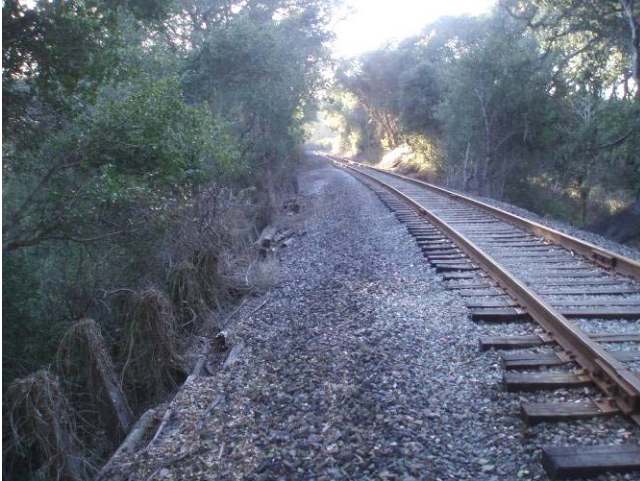
The retaining wall at the left side of this photon near Estates Drive private crossing (near MP 13.7) is leaning outward, with some of the timbers exhibiting signs of deterioration. Further investigation of this structure is required.

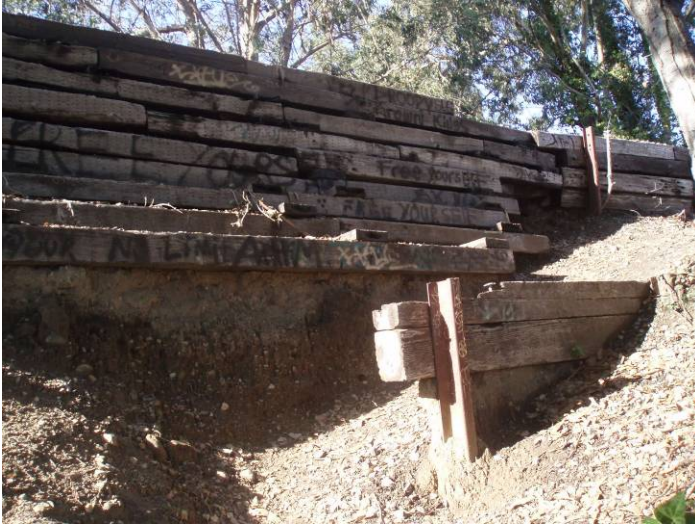
Retaining wall at south approach to the Capitola bridge, near MP 15.8. Pedestrian traffic has badly undermined this wall, a situation which should be addressed immediately.

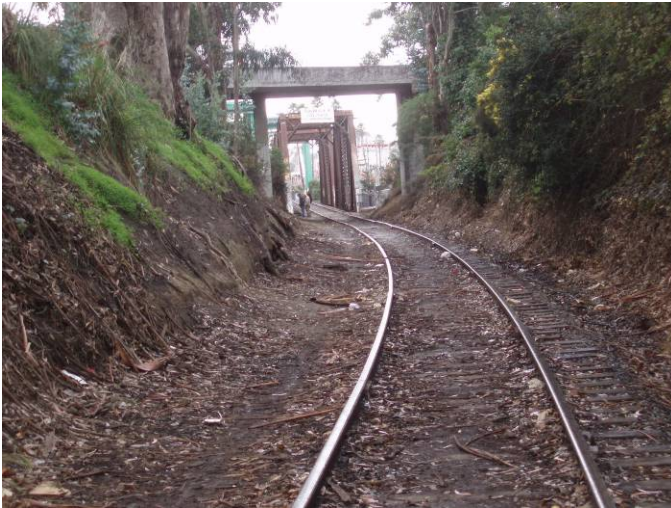
Looking northward from approx. MP 19.4. Erosion from steep cut walls, tight clearances, and pedestrian traffic have clogged drainage ditches and fouled ballast, a problem made worse by debris from overhanging trees.

Re-establishing drainage ditches would be the first step in this segment. For areas of heavily fouled ballast, an approach similar to that discussed in Section 2.3.1 of this report (a combination of cleaning the ballast shoulders, attempting to clean the worst of the fouled ballast from the tie cribs, and a track raise, may be appropriate. If a track raise is considered, the vertical profile at the several grade crossings, and at the vertical obstructions near MP 19.4, must be considered.

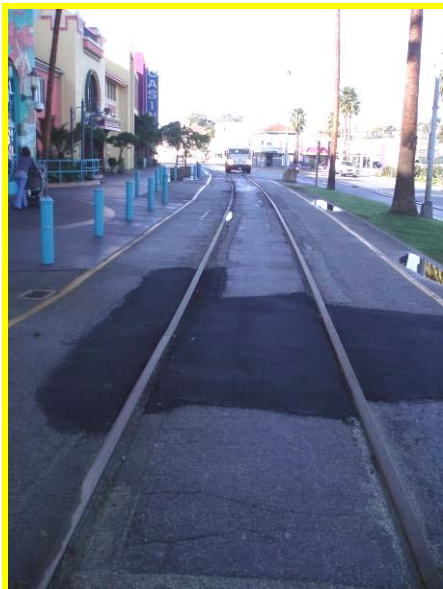
Example of recent spot asphalt repair in front of the Boardwalk (near MP 19.8).

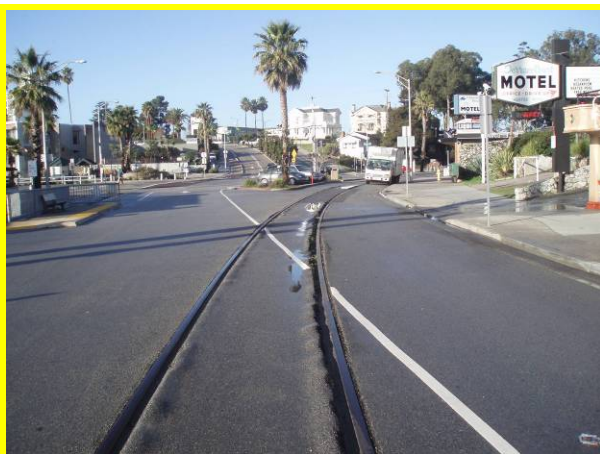
Track in Beach Street, near Pacific Avenue intersection (MP 20.0). We recommend installing concrete crossing panels in this part of the curve.

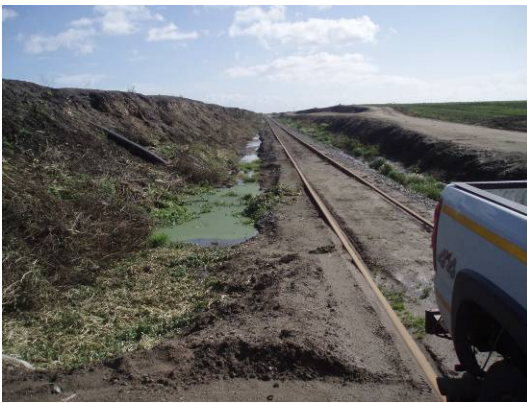
Fouled ballast and poor drainage at the private crossing near MP 25.5.
