Bridge Pin Ultrasonic Testing Report (Capitola Railroad Truss)

CAPITOLA RAILROAD TRUSS

SOQUEL CREEK in CAPITOLA, CA

2012 BRIDGE PIN ULTRASONIC TESTING REPORT

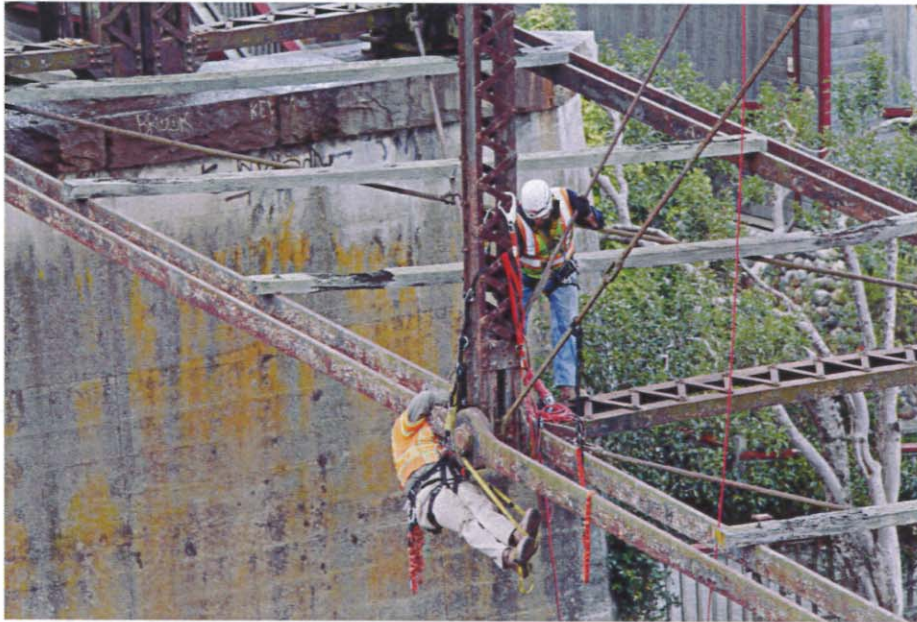
Photograph 1 - View of Technical Access solo climbing techniques being used to examine a lower chord pin.

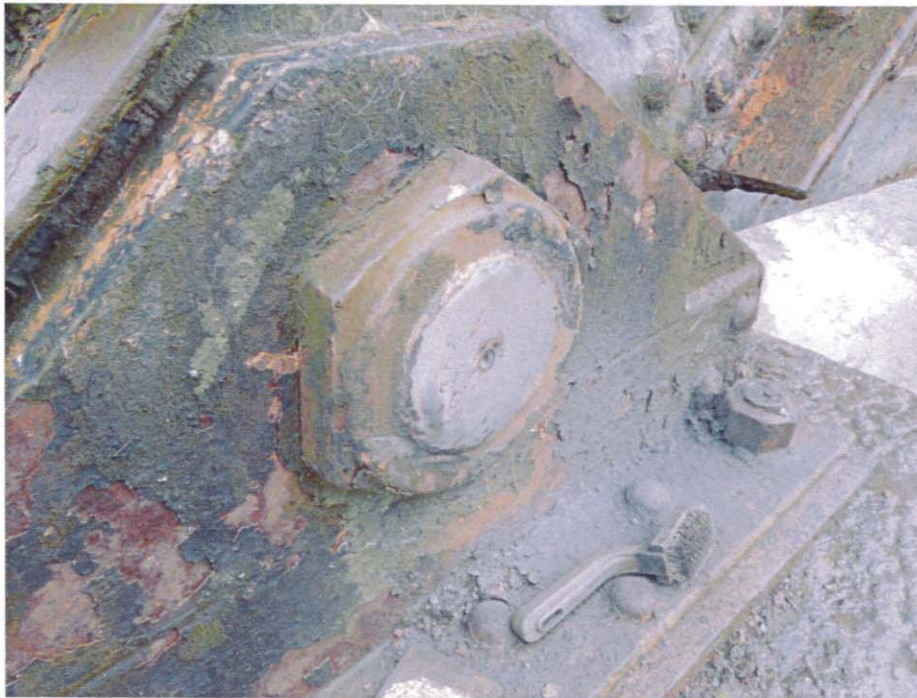
Photograph 2 - View of typical pin face after polishing with a grinder.

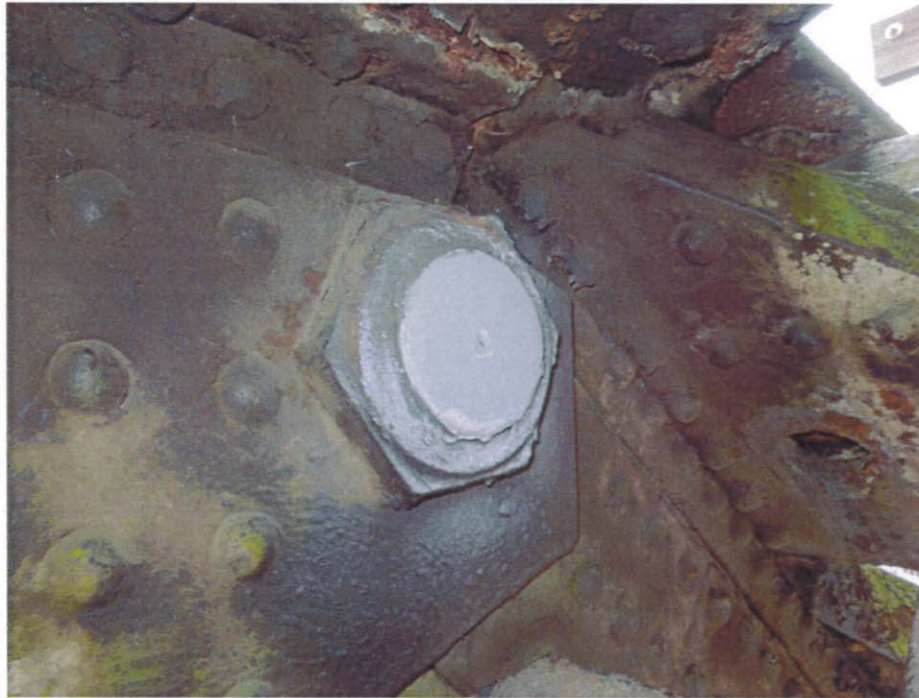
Photograph 3 - View of typical pin face after application of galvanizing paint.

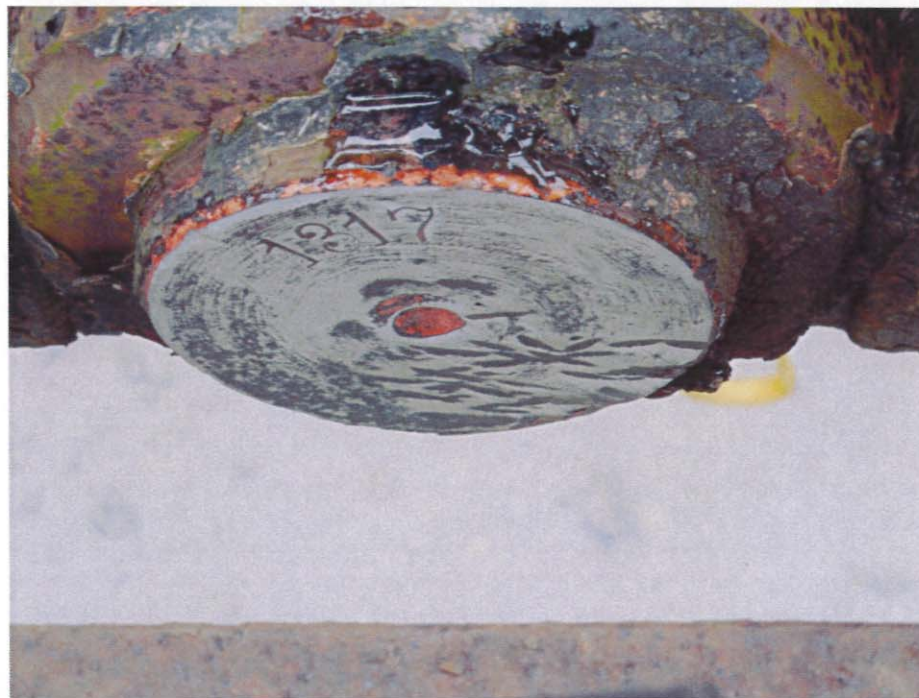
Visually, surface corrosion was typically noted on the end faces of the various pins. Many of the pins have gouges or indentations in the pin faces due to heavy impacts used to drive the pins in place during construction. Some of these indentations are up to 3/16" deep (see Photograph 4). Some of the pin faces also had a raised circular protrusion of approximately 1-1/2" diameter x 3/16" thick at the center of the pin (likely leftover from the manufacture of the pins). These protrusions were ground smooth to achieve a better testing surface. The few locations where the barrels of the pins were exposed had pitting from corrosion; however, the configuration of the eyebar-pin setup made measurements of the corrosion difficult and inaccurate (see Photograph 5). At Panel Point U4E, the edges of the pin were previously rounded for approximately 3/4" wide throughout its circumference and the pin has numerous deep gouges both faces (see Photograph 6). Representative A-Scans, depicting typical pin conditions, are included in Appendix C.

Photograph 4 - Panel Point L2E. View of surface gouges in the inboard pin face.

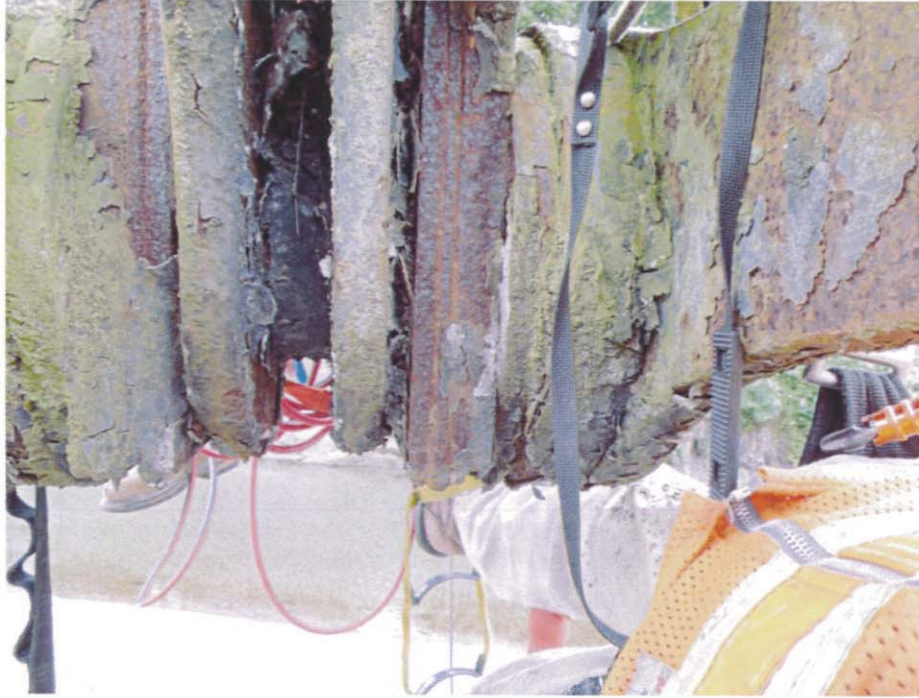
Photograph 5 - Panel Point L2E. The barrel of the pins were typically not available for visual inspection.

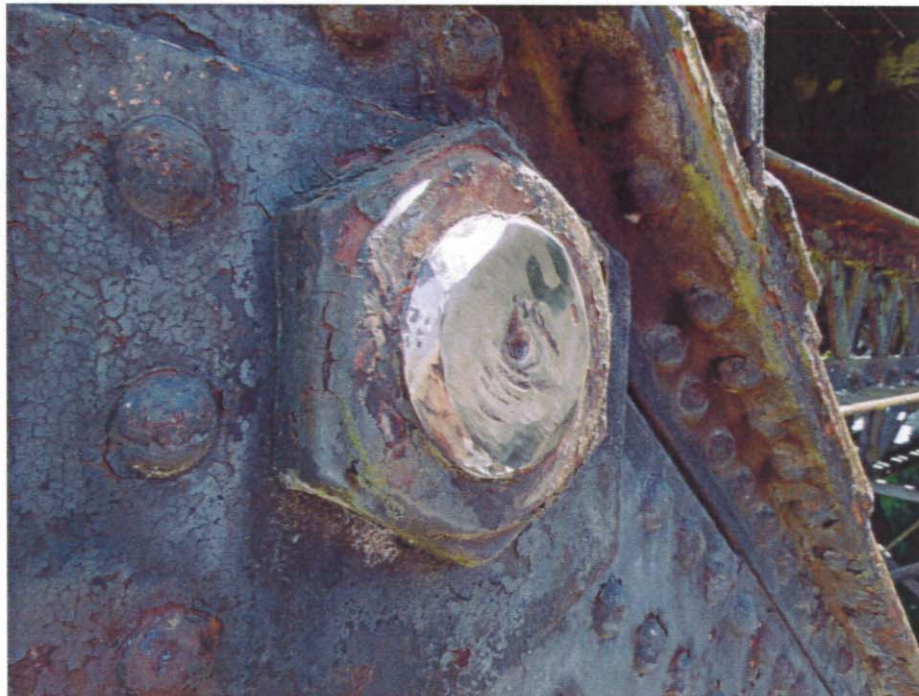
Photograph 6 - Panel Point U4E. The edges of the pin's outboard face have been previously rounded for up to 3/4". The pin face also has deep gouges throughout both faces.

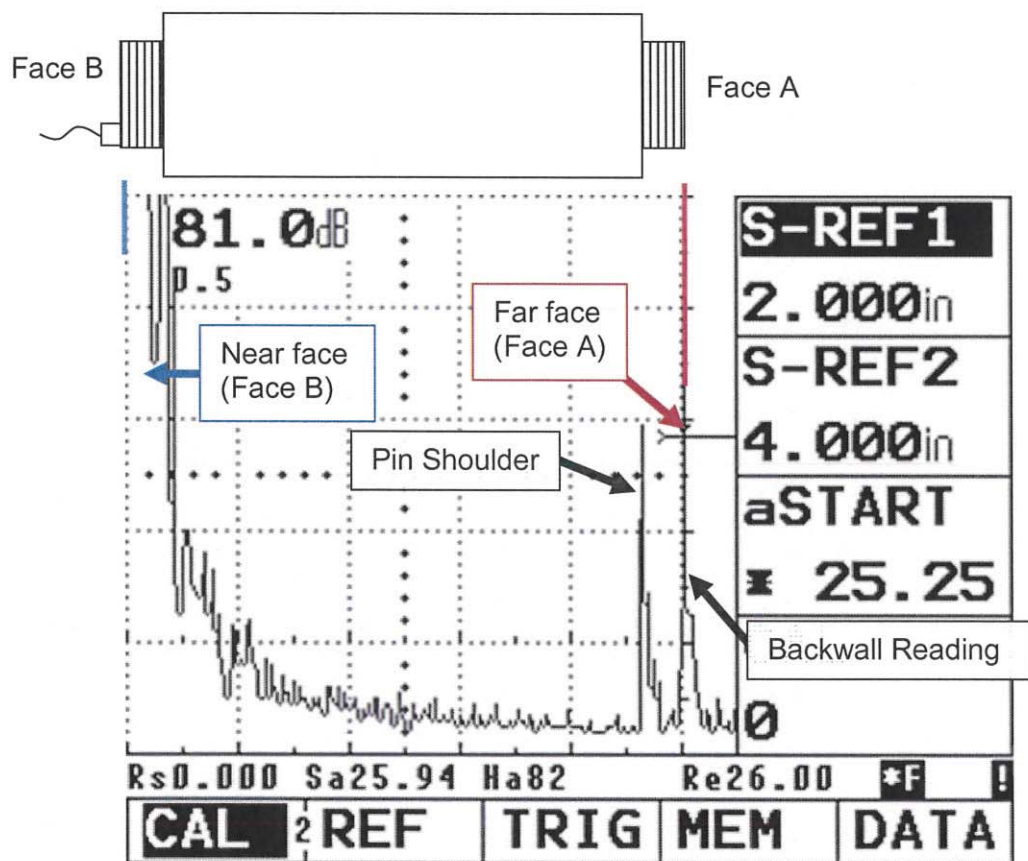
A-scan 22- Panel Point LOW. View of a typical pin backwall reading viewed from Face B.

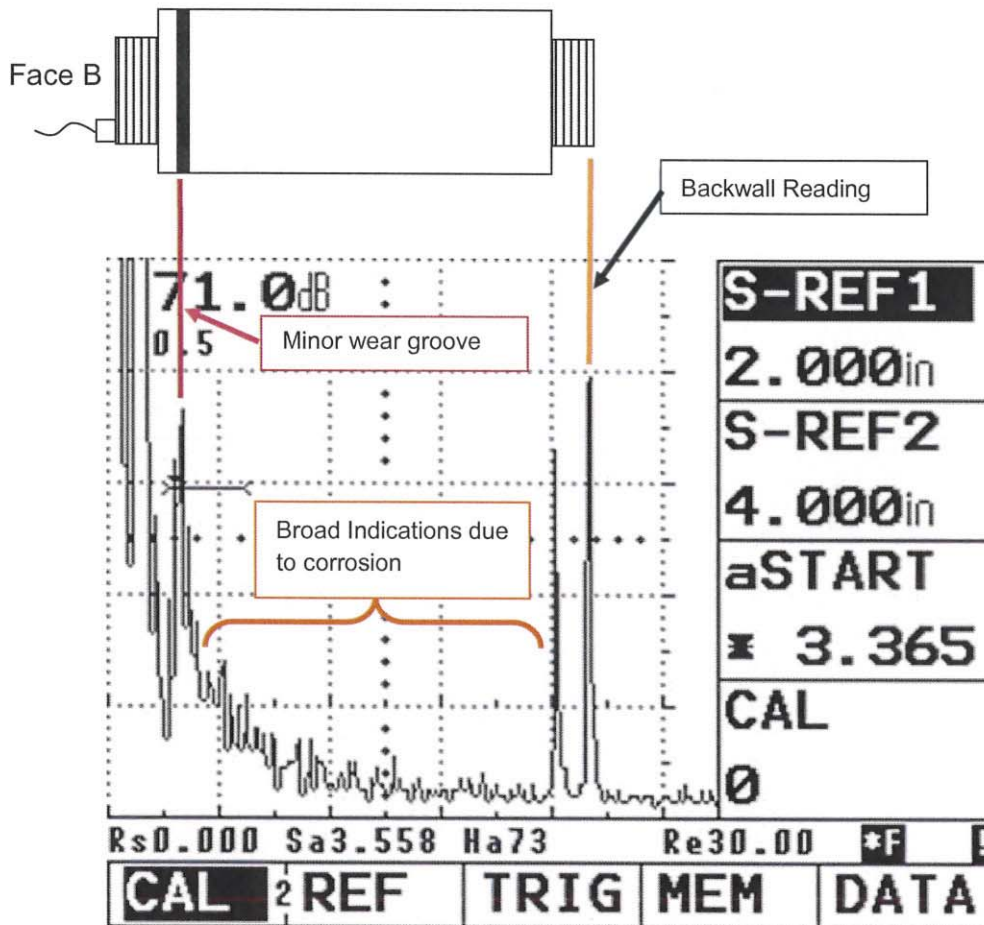
A-scan 44- Panel Point L5W viewed from Face A. There is a full-circumference wear groove located 3.558" from Face A. Minor corrosion is also present throughout the surface of the pin barrel as indicated by the numerous shallow indications between the pin shoulders. The data set was recorded at Reference Level, so the minor indications are approximately 1/16" deep. Ratings minor are a function of return signal attenuation for a given depth from the scanned pin face. For this reason, smaller indications at a greater depth from the scanned face are more significant than large indications closer to the scanned face.

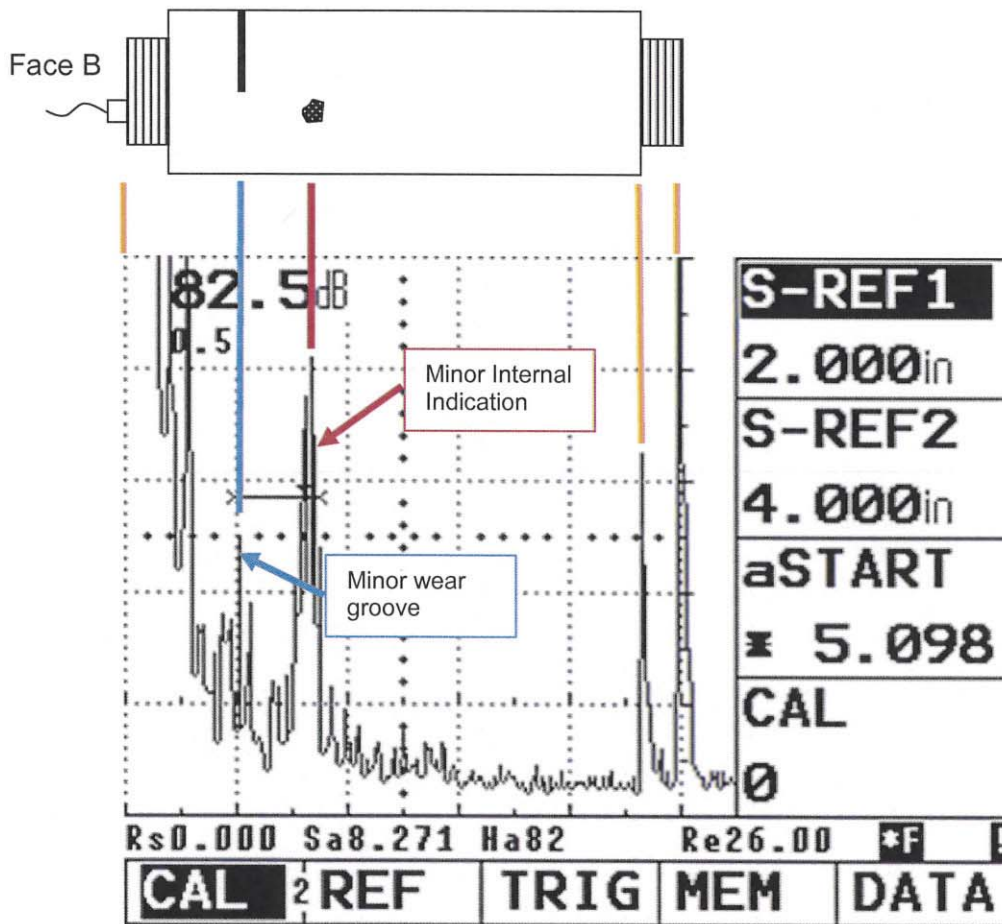
Internal indications are generally characterized as small in magnitude of return signal at very isolated locations within the body of the pin. Internal indications were found in four pins: L0W, L0E, U1W and L2E. The internal indications have return signal characteristics consistent with small inclusions, piping or porosity and do not extend to the pin surface. It is likely that these internal defects have existed since the fabrication of the pins.

A-Scan 21 - Panel Point LOW viewed from Face A. There is an approximately 1" diameter internal inclusion in the pin located 8.271" from Face A. The indication is located 1" from the center of pin at 12:00. There is also a minor wear groove from 3:00 to 9:00 located 4.390" from Face A.

During the next ultrasound investigation, it is recommended that particular attention be paid to the truss pins that exhibited internal indications at Panel Points L0W, L0E, U1W and L2E, and the two upper chord pins with surface indications at Panel Points U1W and U2E.
