SANTA CRUZ METRO'S Line 71/Rapid Corridors Project

ITAC Update

September, 21 2023

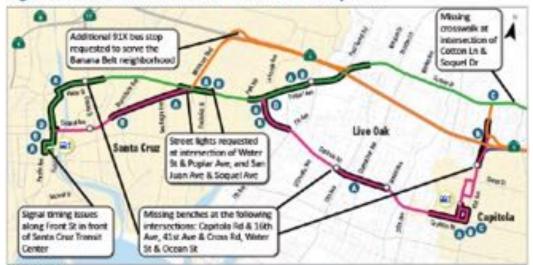
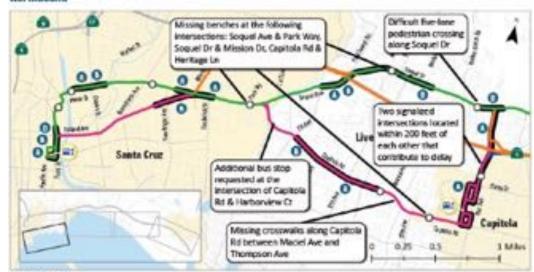
Figure IA: Problem Identification - Santa Cruz to Capitola

- Missing amenities at bus stops (69% without shelters and 31% without benches)
- Improper location (53% of stops are mid block or near sided)
- Lack of protected crosswalks near stops
- Discontinuous sidewalks
- Signal coordination issues

- Delay due to congestion of up to 20 mins/trip
- Dwell time between 20 and 45 mins/trip
- Greatest variability entering/existing downtown Santa Cruz and near Green Valley Road on Freedom Blvd
